**MT-RAP-2008-00100/mso**

**Summary of coating surveys  
on the four air command frigates  
(Zeven Provinciën class)**

Date	March 26, 2008
Author	R. van der Kaaden, B.Sc. (TNO Quality Services B.V.)
Client	Ministry of Defence DMO / DWS / RZS / PLTFT Corrosion Prevention Attn. of Mr. H. Bakuwel, B.Sc. MPC 58 A P.O. Box 90822 2509 LV The Hague
Classification report	Unclassified
Classified by	H. Bakuwel, B.Sc.
Classification date	March 12, 2008
Title	Unclassified
Managementuittreksel	Unclassified
Abstract	Unclassified
Report text	Unclassified
Appendices	Unclassified
Copy no	18
No. of copies	22
Number of pages	40
Number of appendices	1

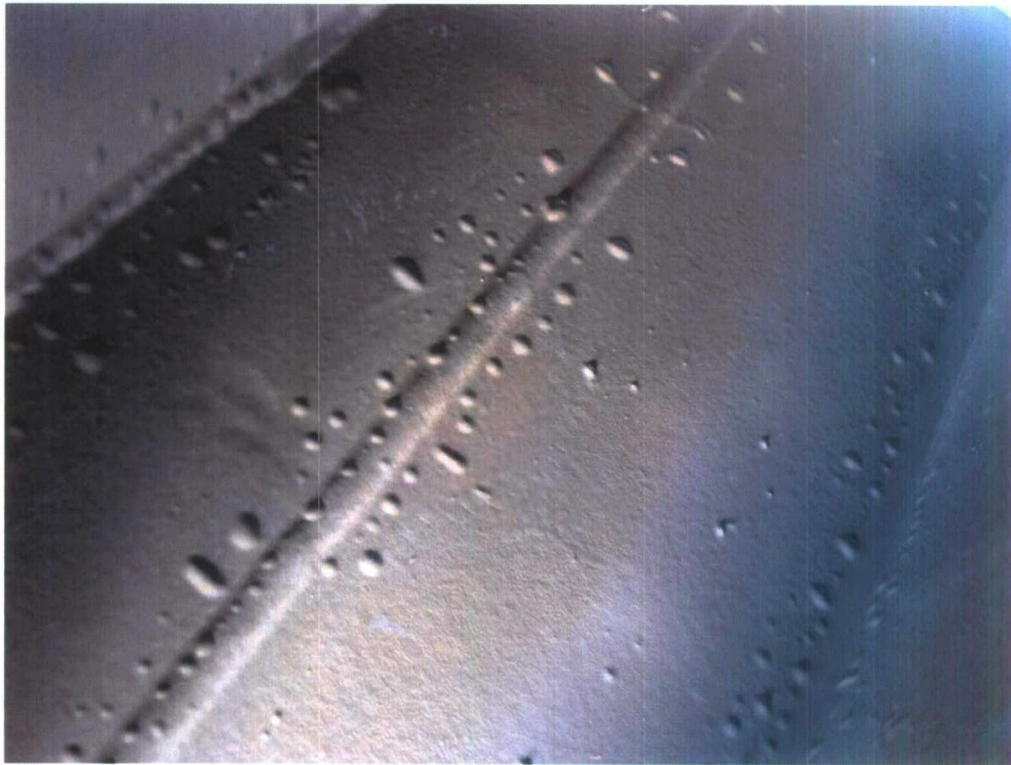
- Generally, the adhesion in blistered areas is poor. The area affected by blistering varies from 2,5 m<sup>2</sup> to 20 m<sup>2</sup> per tank. Two spots showing spontaneous detachment in blistered areas resulting in corrosion of the underlying steel have been disclosed in tank 1 of LCF 1. Such a propagation of the damages is highly undesired. In all other tanks, blisters are still intact.

- The observed blisters should not occur in a coating system which has been applied according the regulations and performs satisfactorily.
- Blistering in potable water tanks of LCF 1 was already observed prior to delivery of the vessel (information DMO).

Photo 1: Hr.Ms. "Zeven Provinciën" (LCF 1). Potable water tank 2 (07.11.2006).  
Blistering along welds/welding corners in stripe coated areas.

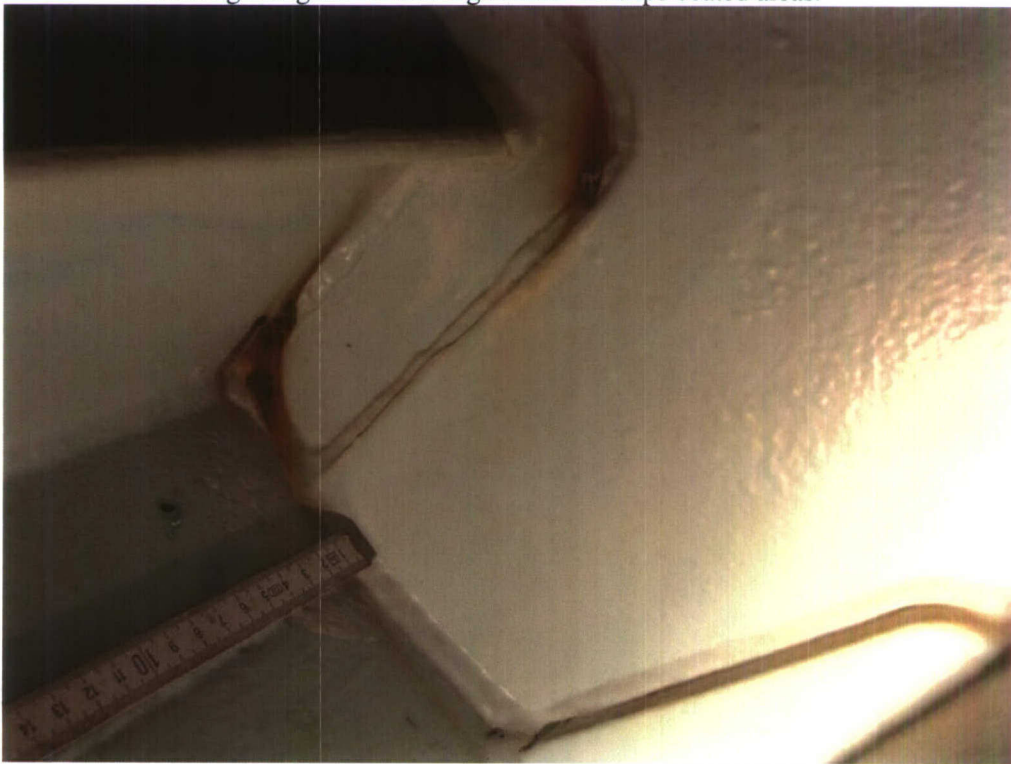
- Typically, the surface structure of the coating is wrinkled (surface as well as in between blisters).
- Taking into account the limited surface of the tanks relatively many (small) corrosion spots are present along welding seams and edges (photo 2).

Photo 2: Hr.Ms. "Tromp" (LCF 2). Potable water tank 4 (02.08.2006).  
Corroded spots along welds.

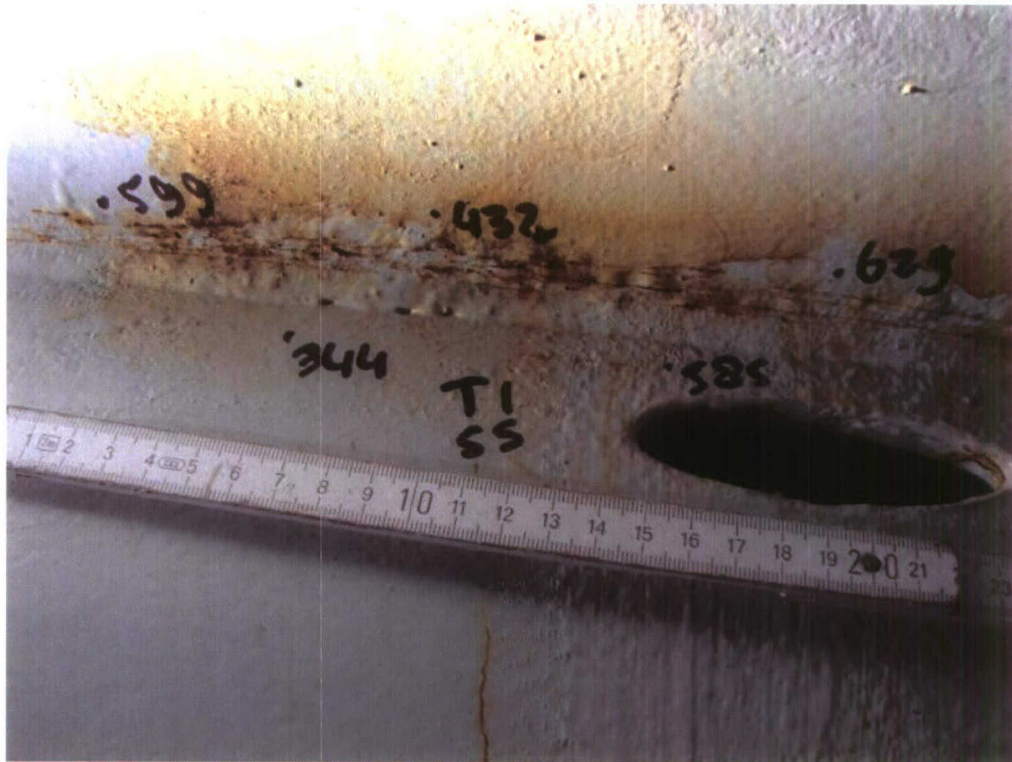
- Cracking in the coating along welding seams occurs in ballast tank 2 of LCF 1 (photo 3), ballast tanks 1 and 2 of LCF 2 (photo 4) and in a limited amount in ballast tanks 1 and 3 of LCF 4. The coating thickness is normal and not excessively high. Water ballast tanks of LCF 2 have been used to a higher extent compared to LCF 1 and 3.

Photo 3: Hr.Ms. "Zeven Provinciën" (LCF 1). Water ballast tank 2. (06.09.2006).  
Cracks in coating along deckhead weld.

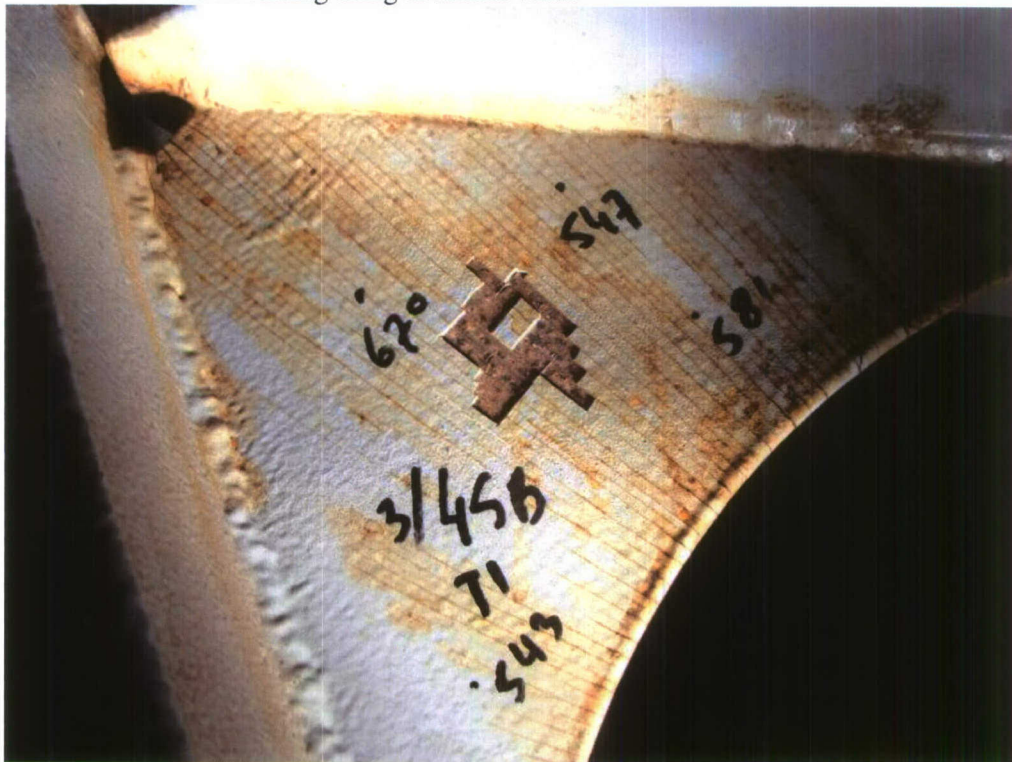
Photo 4: Hr.Ms. "Tromp" (LCF 2). Water ballast tank 1. (11.08.2006).  
Cracks in coating on bracket. Limited undercreep of corrosion from cracks.

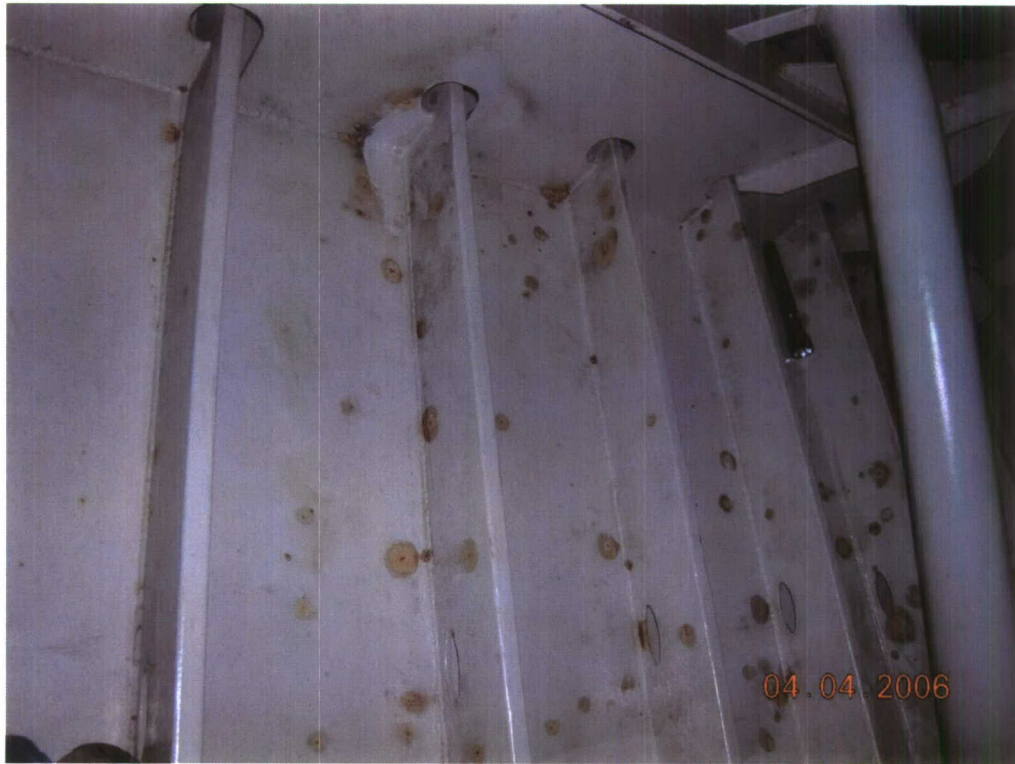
- Considering the limited surface of the tanks, very many to extreme amounts of (small) corrosion spots are present on surface and on welding seams (photo 5).

Photo 5: Hr.Ms. "Evertsen" (LCF4). Water ballast tank 1 (04.04.2006).  
Large numbers of mechanical damages with protruding corrosion and staining.

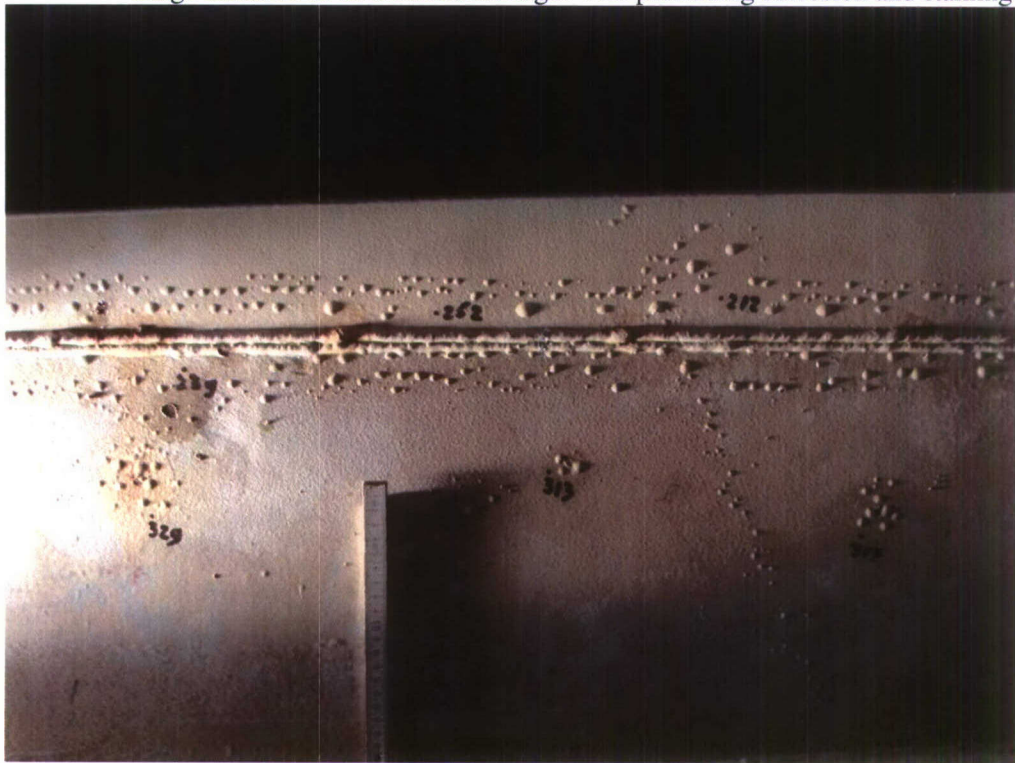
- Cathodic blistering has developed in the coating around damages, pinholes and on poorly covered spots. These alkaline blisters between steel and coating are formed due to the cathodic protection in the tanks. This phenomenon mainly occurs in ballast tanks 1, 2 and 4 of LCF 1 and ballast tank 5 of LCF 3 (photo 6).

Photo 6: Hr.Ms. "De Ruyter" (LCF 3). Water ballast tank 5 (08.11.2006).  
Poorly covered weld with substandard coating thickness and cathodic blistering.

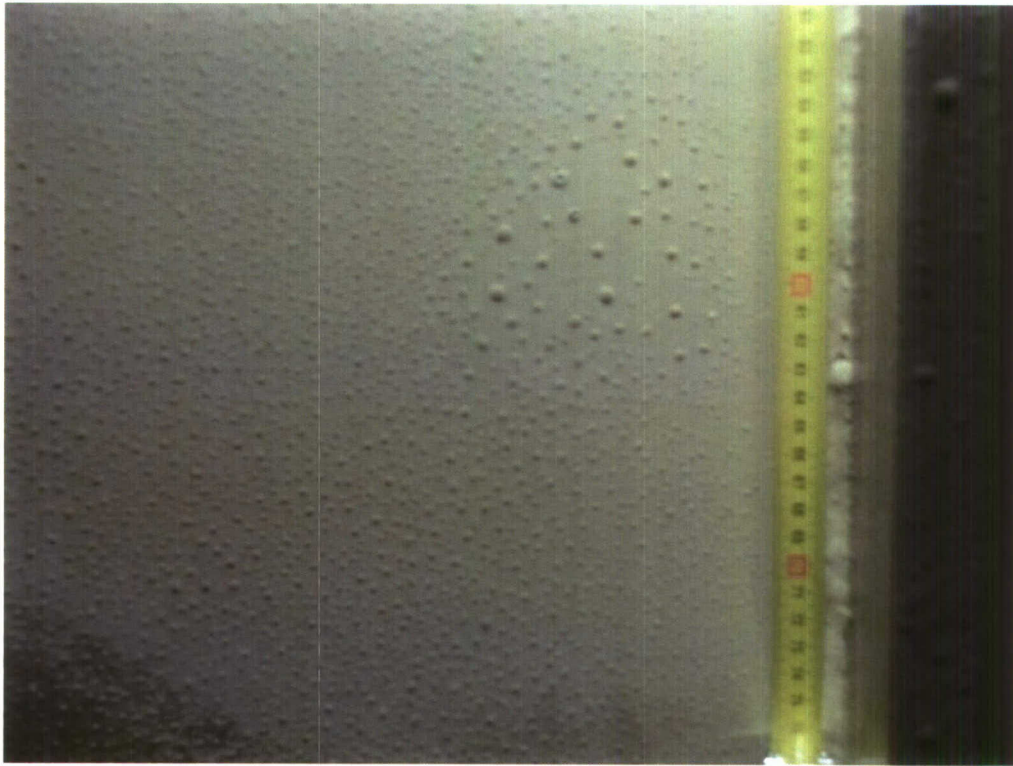
- Especially in the collection tanks, significant areas have been affected by blistering (photo 7). On LCF 4, the first frigate to be inspected, blistering had occurred in various places within the coating system. Subsequent inspections on LCF 1, 2 and 3 proved that blistering is a structural problem.
- Blistering has also occurred in the sewage storage tanks though to a far lesser extent.
- Both in the sewage collection and storage tank, corrosion is limited to a few spots (photo 8). As far as could be assessed, deep steel wastage has not occurred.
- The extremely poor condition of Cunifer piping in the tanks of LCF 1 (perforations) was striking (photo 9). GRP piping has been installed instead on all LCF's.

Photo 7: Hr.Ms. "Tromp" (LCF 2). Sewage collection tank (11.07.2006).  
Severe blistering on bulkhead.

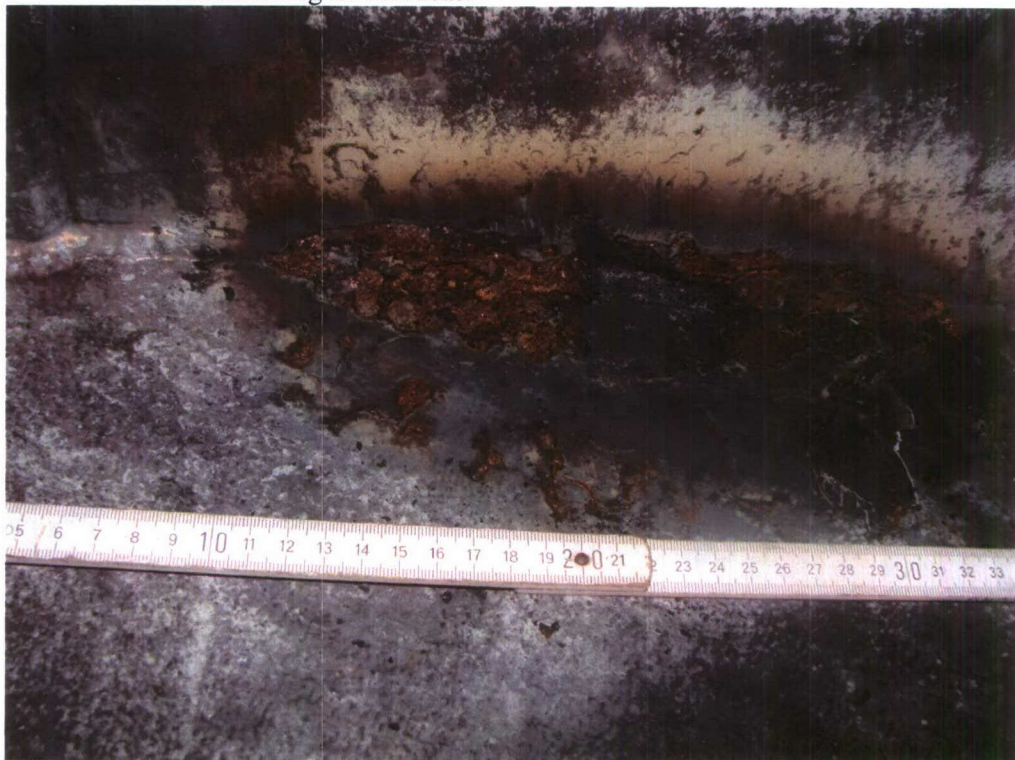
Photo 8: Hr.Ms. "De Ruyter" (LCF 3). Sewage storage tank (13.11.2006).  
Corrosion on tank bottom.

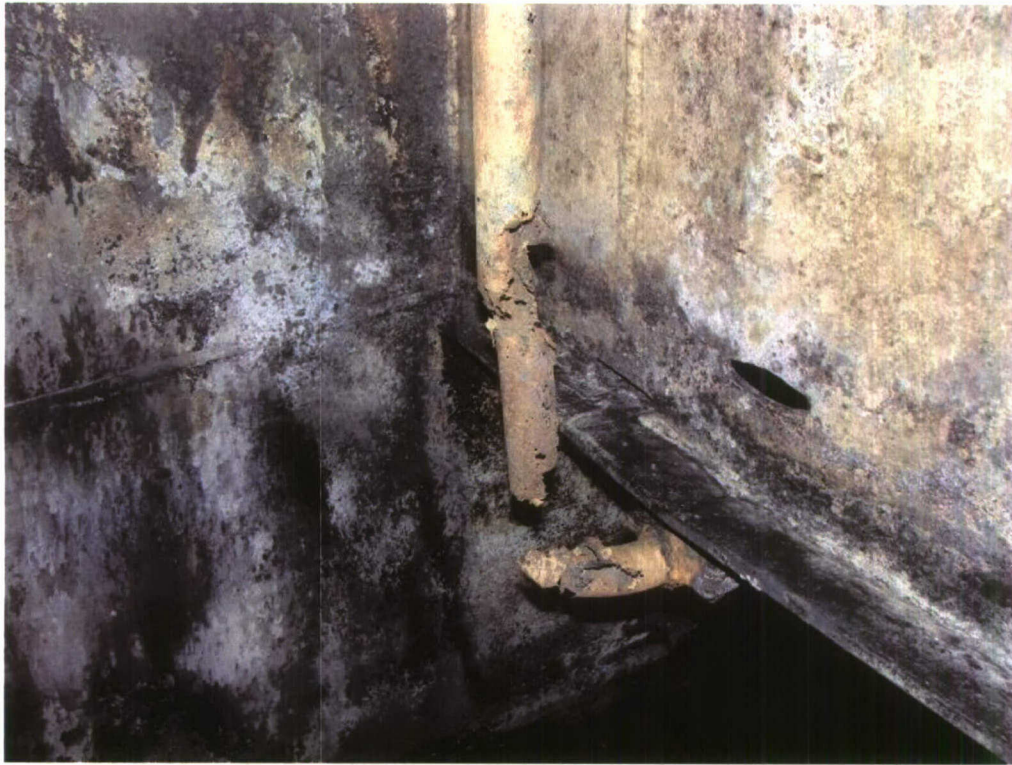
Photo 9: Hr.Ms. “Zeven Provinciën” (LCF 1). Sewage storage tank 3 (11.09.2006). Severe wastage of Cunifer piping in SB compartment and under sewage collection tank.

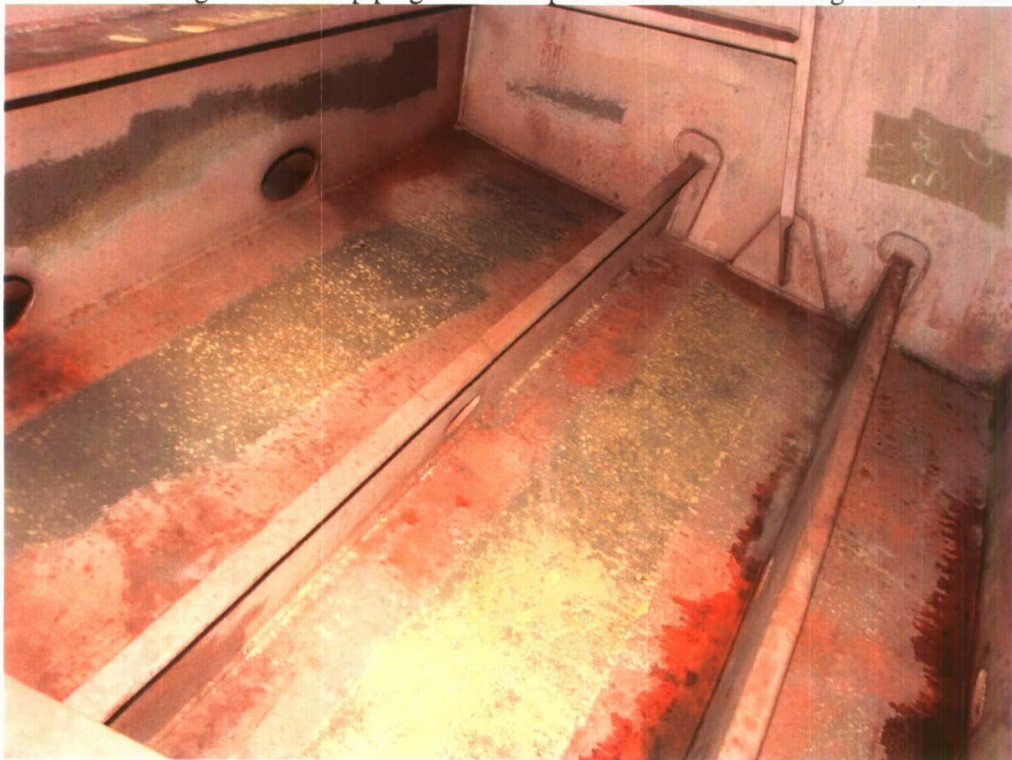
- Only on LCF 1, several of the tanks have not been coated completely, as was the case on a few frame fields on LCF 2. Due to this, uncoated areas have developed corrosion, which has resulted in relatively large areas with damages (photo 10).

Photo 10: Hr.Ms. “Zeven Provinciën” (LCF 1). Fuel storage tank 3 (26.06.2006). Areas which have not been primed have developed corrosion.

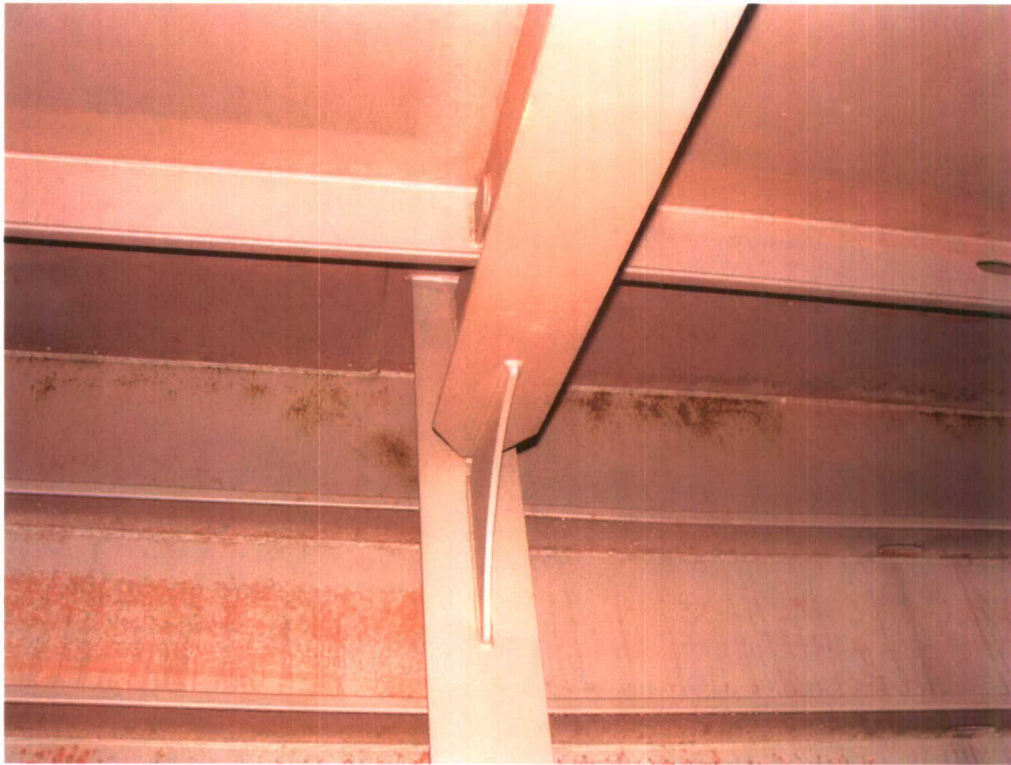
- In fully coated tanks, the amounts of corrosion are generally low (photo 11). Pitting corrosion has been observed (by DMO) only in a bottom panel in fuel consumption tank 2 on LCF 1.

Photo 11: Hr.Ms. "De Ruyter" (LCF 3). Fuel consumption tank KVD/DG SB (14.11.2006).  
Corrosion on hull plating in corner towards deckhead.

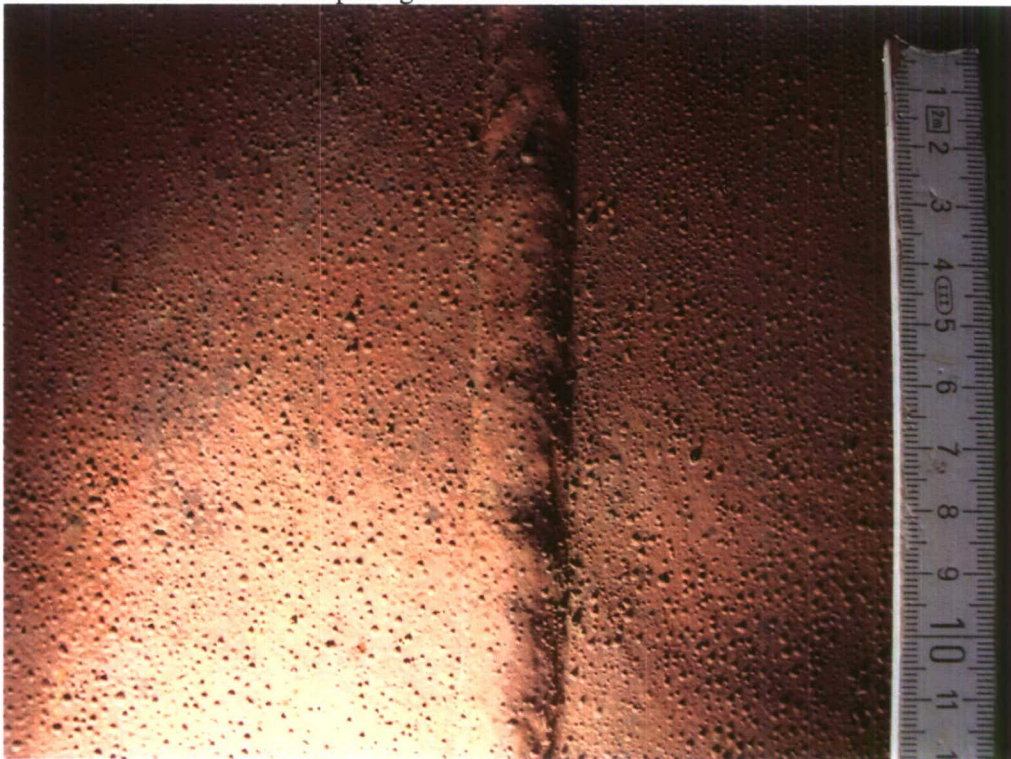
Photo 12: Hr.Ms. "Tromp" (LCF 2). Fuel storage tank 1 (03.08.2006).  
Dense blistering on tank bottom.

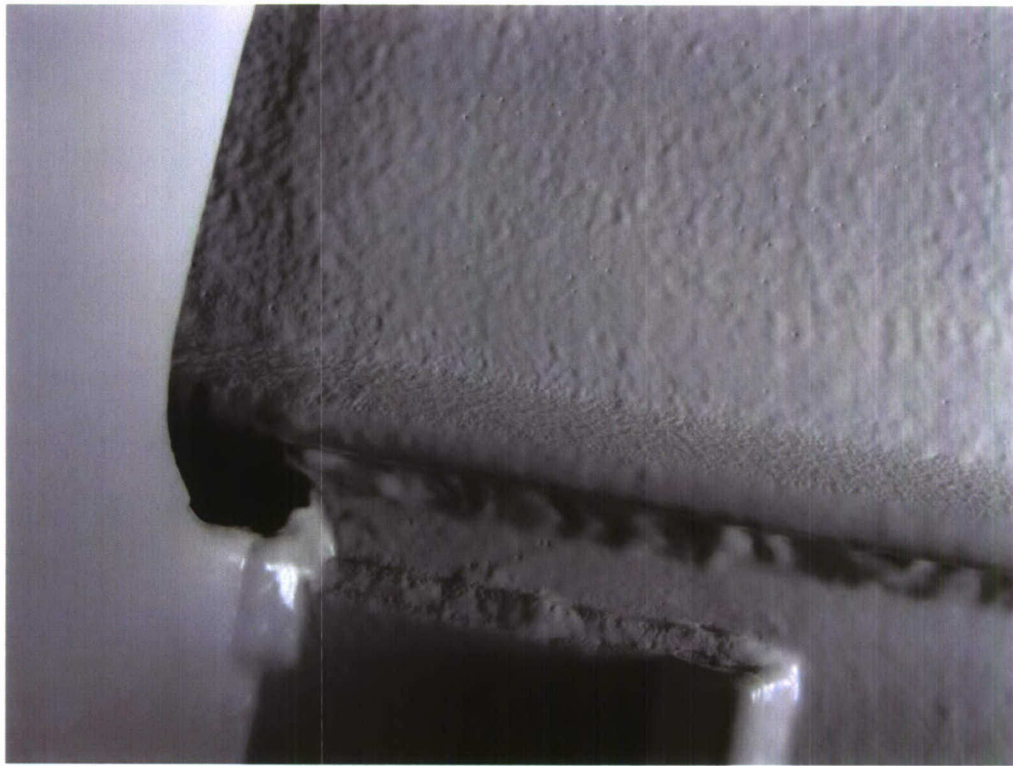
Photo 13: Hr.Ms. “Zeven Provinciën” (LCF 1). Heli fuel storage tank (21.08.2007).  
Poorly covered edges and pinhole formation in topcoat.

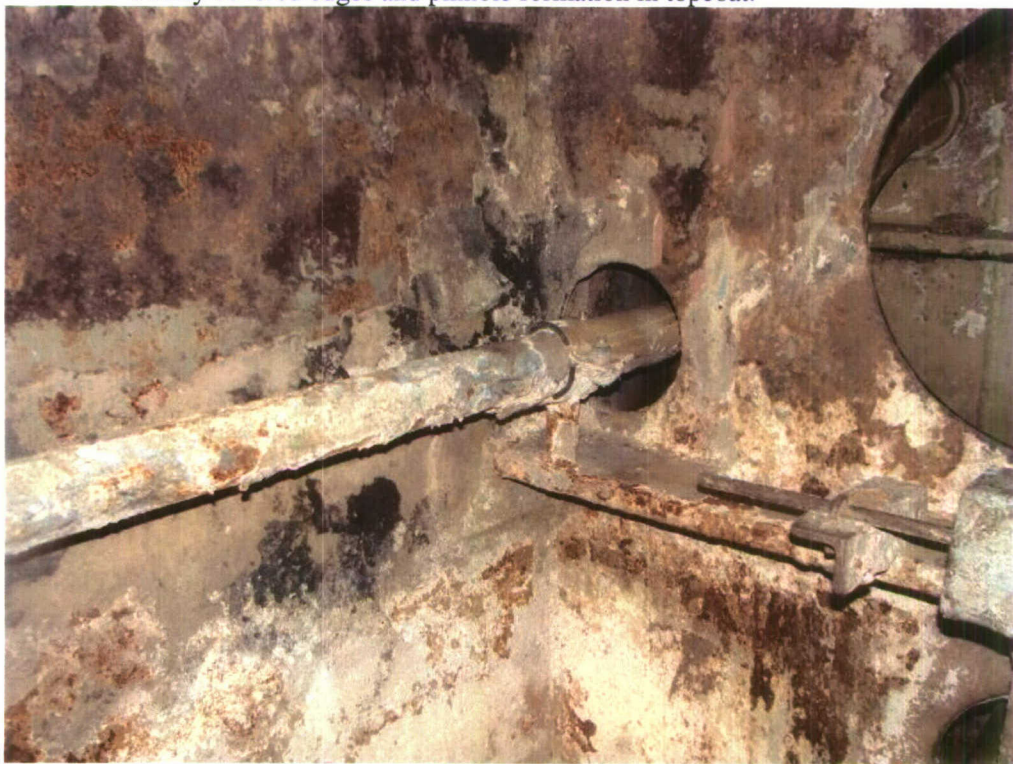
Photo 14: Hr.Ms. “Zeven Provinciën” (LCF 1). Grey water tank 2 (26.06.2007).  
Severe breakdown on forward and starboard bulkhead.

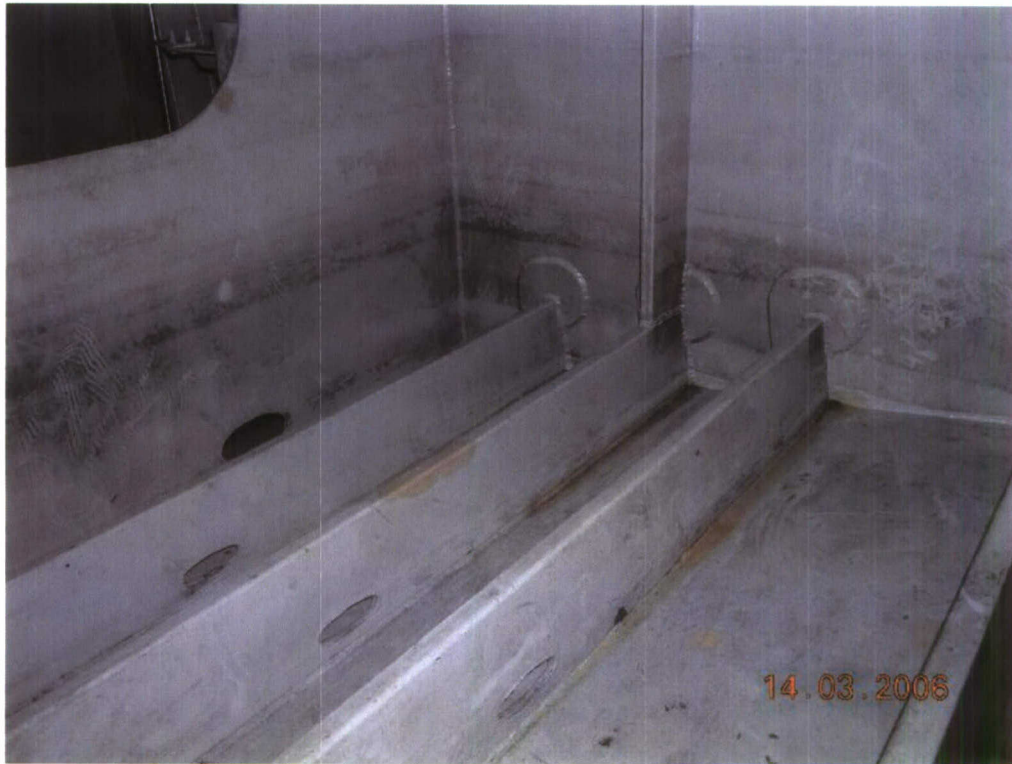
Photo 15: Hr.Ms. "Evertsen" (LCF4). Bilge water collection tank (14.03.2006).  
Corrosion along poorly covered weld in centre compartment.

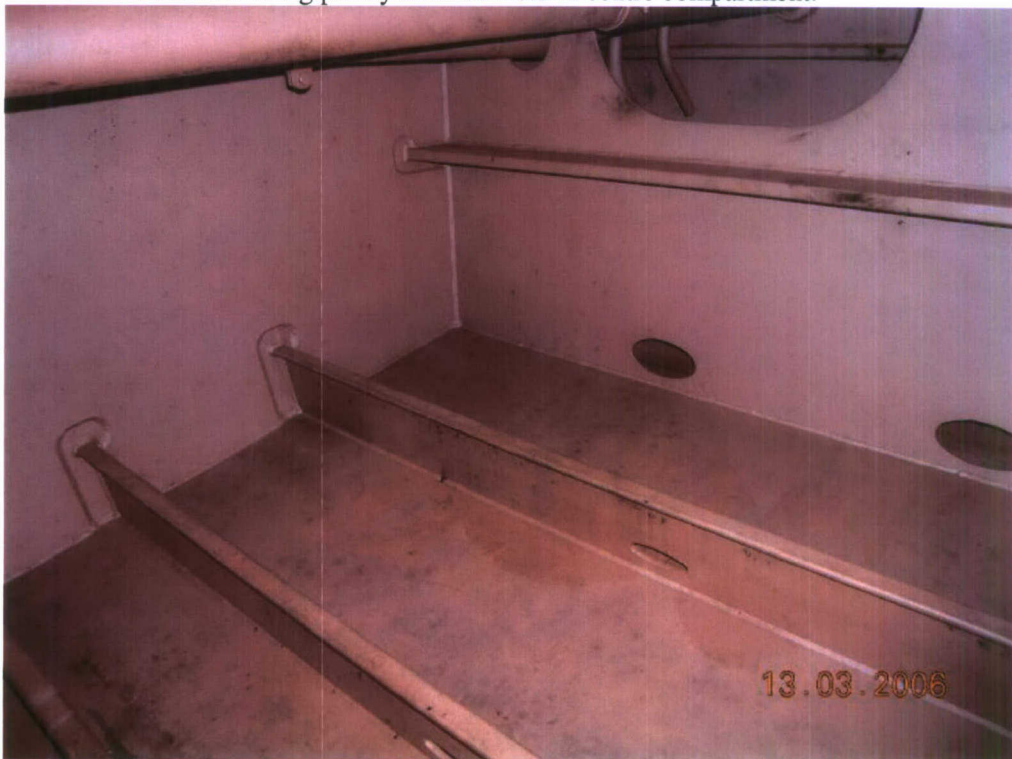
- Generally, the coating system in the tanks is in a good condition (photo 16).
- The dirty oil tank on LCF 1 is the only tank of four where the surface has not been coated completely. Uncoated areas cover 20-30 % of the surface. As a result, especially the lower bare steel surfaces have developed corrosion here. Furthermore, some local blistering has been observed within the primer coating.
- Some minor pitting corrosion could be observed in two compartments on LCF 1 and one compartment on LCF 4.
- Some corrosion is occurring along welds.

Photo 16: Hr.Ms. "Evertsen" (LCF4). Dirty oil tank (13.03.2006).  
Overview of a part of the centre compartment.

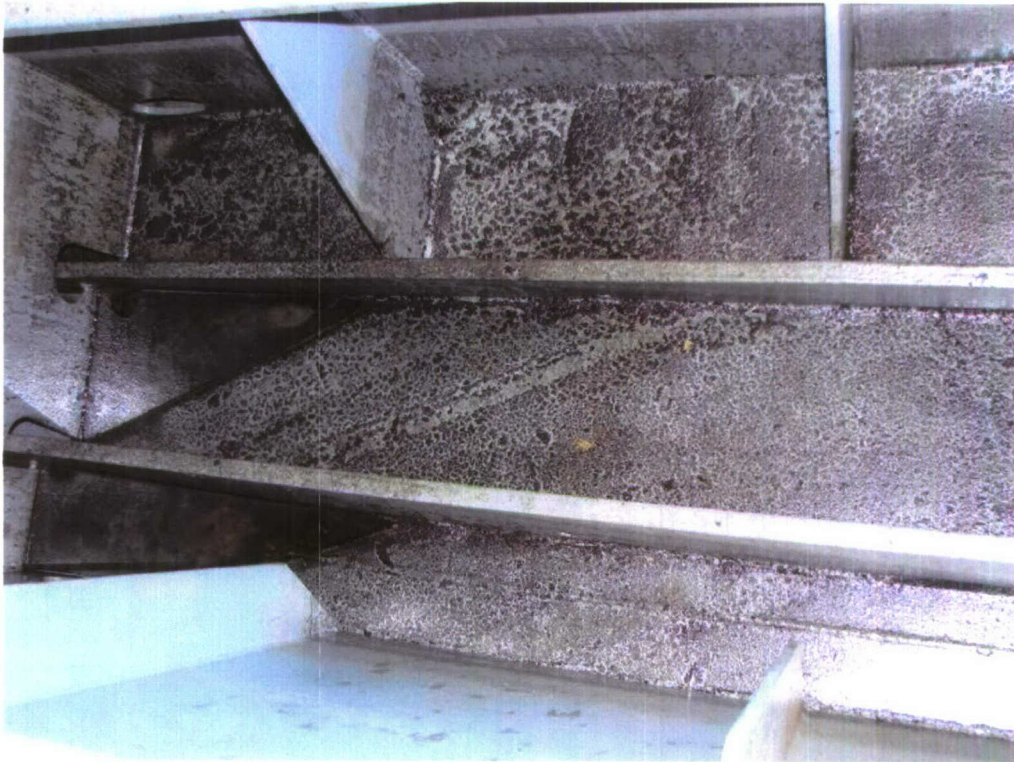
Photo 17: Hr.Ms. "Zeven Provinciën" (LCF 1). Dieselgeneratorroom (25.06.2007).  
Dirty, oily bottom area with staining due to corrosion of metal particles on top of coating.

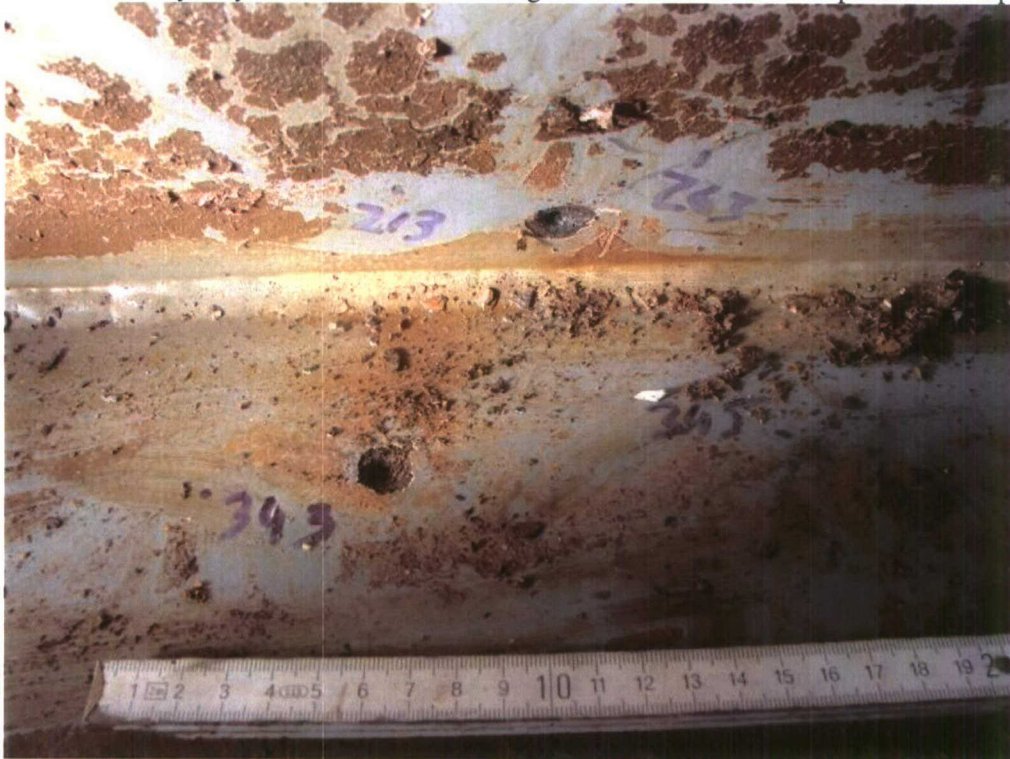
- On all LCF's, pitting corrosion has been observed in bilges, especially in pump rooms 2 and 3 (photo 18). The depths of the pits varied from approx. 1 mm up to 6-7 mm.
- A black substance was present in the pits.
- Additional investigations have been carried out into the cause of pitting in pump room 2 on LCF 1. Sulphur reducing bacteria have been identified, as well as fungi. Sulphur reducing bacteria can result in pitting corrosion. Access to the steel was possible due to the mechanical damages.
- As can be expected in bilges, the coating system frequently shows corrosion as a result of mechanical damages. Additionally metallic particles are present on the coating surfaces, which develop corrosion.
- Cracks due to high coating thicknesses sometimes reaching the steel resulted in penetrating corrosion.

Photo 18: Hr.Ms. "De Ruyter" (LCF 3). Pump room 3 (14.11.2006).  
Pitting corrosion on hull and vertical side in compartment 3 from fore.

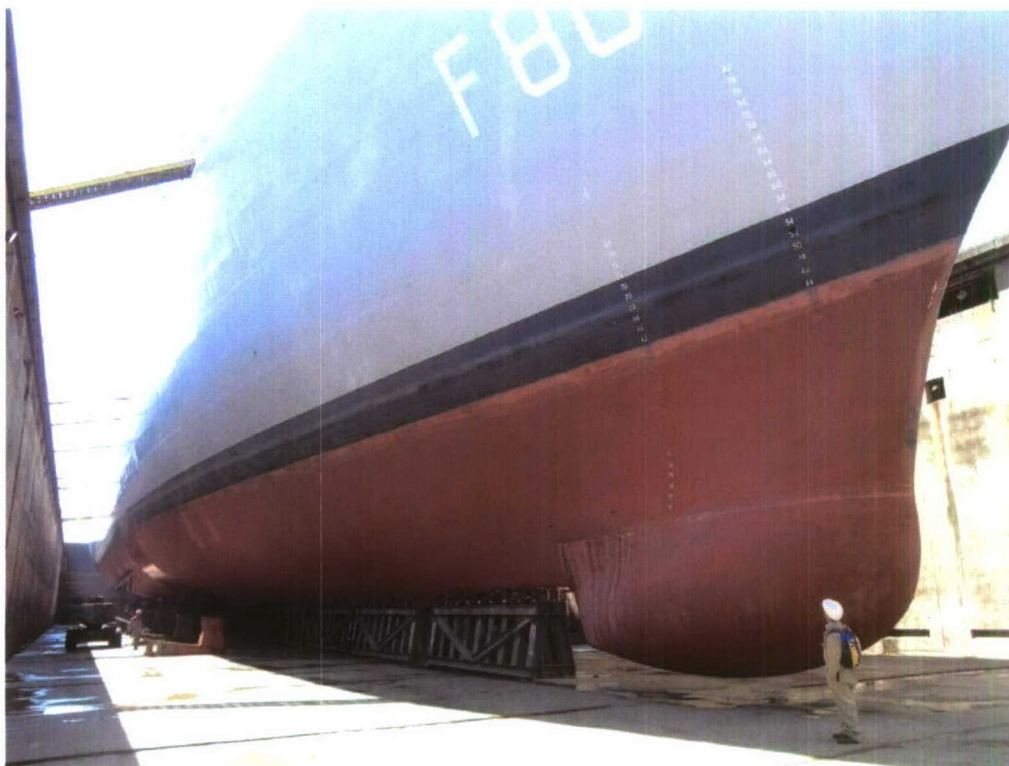
- The underwater hull coating system of LCF 1 and 2 is in a significantly better condition compared to LCF 3 and 4.
- The values in the table show that detachments have occurred on the hulls coated with AlphaGen antifouling only. Significant surfaces have detached both between antifouling layers and, to a lesser extent, between tiecoat and antifouling (photos 19 and 20).

Photo 19: Hr.Ms. "Tromp" (LCF 2). Underwater hull (28.06.2006).  
The SB forward surface area is in excellent condition.

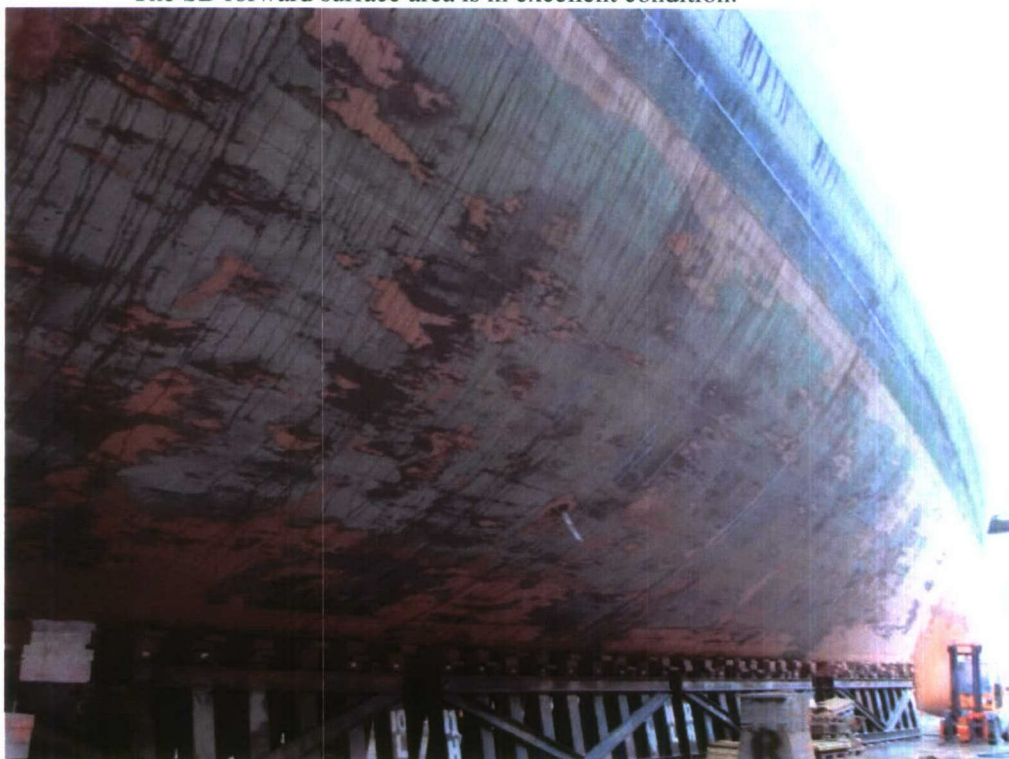
- Due to the detachments, the condition of the hulls of LCF 3 and 4 is poor. The fact that similar problems have occurred on two hulls points in the direction of a product related cause. Insufficient cleaning prior to application of the final coating layer, which was submerged about one year, has been considered as a possible cause before, the likelihood though can be doubted. Application conditions are unknown but could have had an impact as well.

Photo 20: Hr.Ms. "De Ruyter" (LCF 3). Underwater hull (07.12.2006).  
Significant detachment of antifouling on SB forward area.

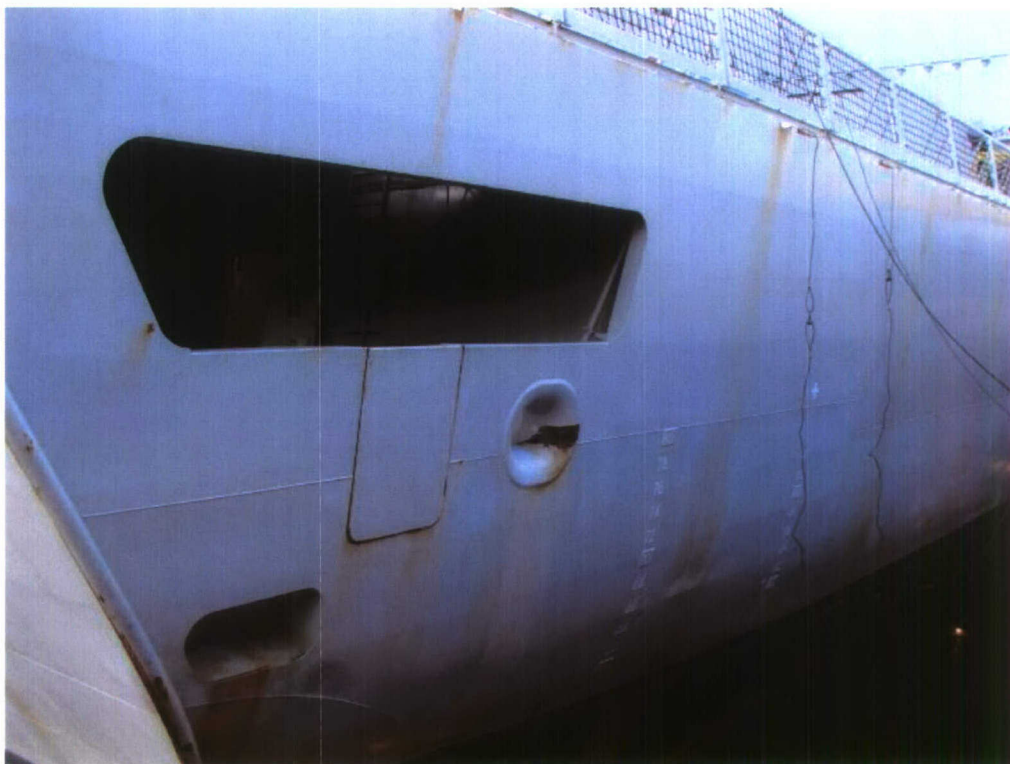
Photo 21: Hr.Ms. "De Ruyter" (LCF 3). Topside (07.12.2006).

Corrosion along edges and staining of corrosion products on SB aft area.

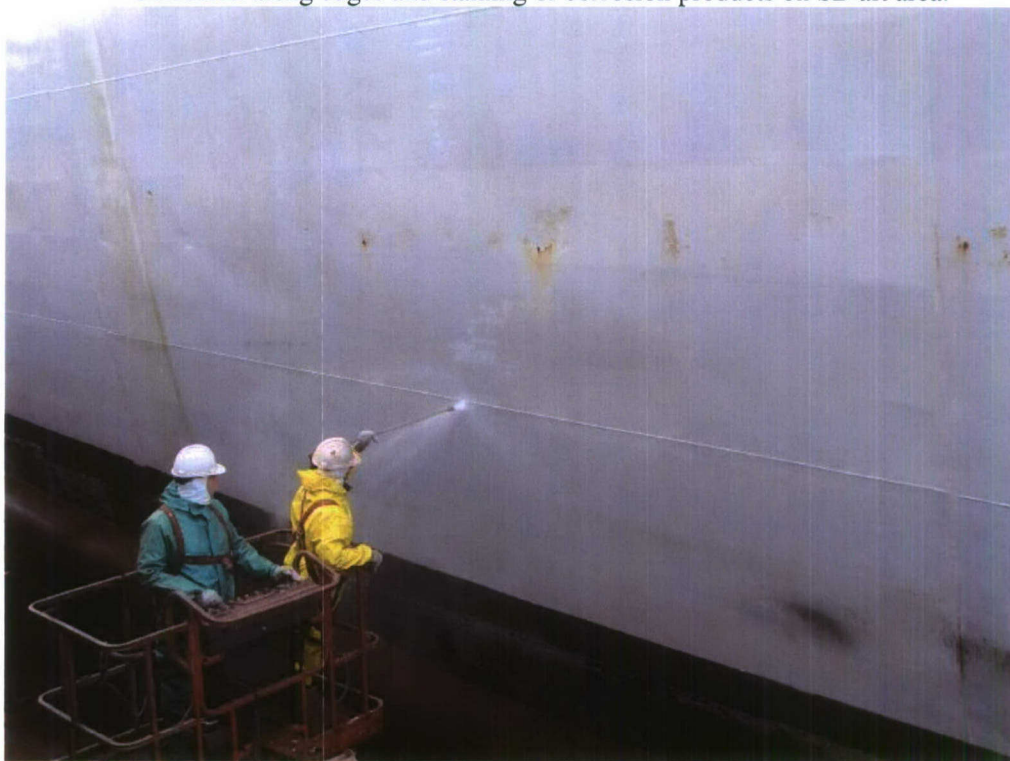
Photo 22: Hr.Ms. "De Ruyter" (LCF 3). Topside (07.12.2006).

Corroded spots and detachment of touch up layer on SB during cleaning.

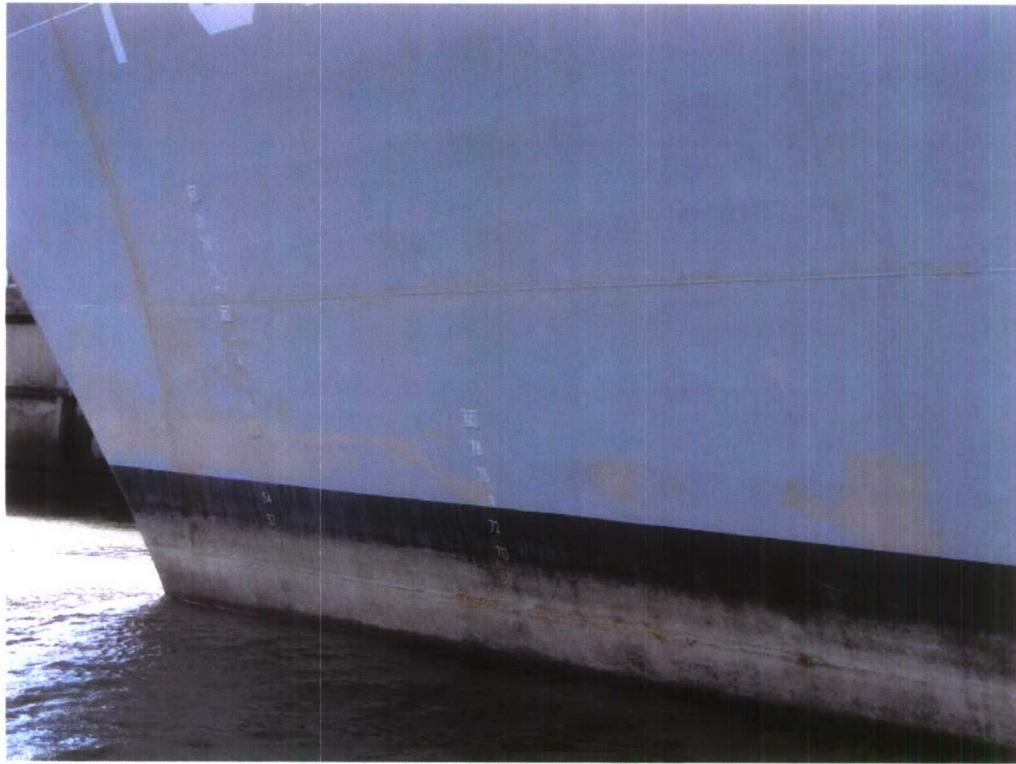
Photo 23: Hr.Ms. "Zeven Provinciën" (LCF 1). Topside (22.08.2007).  
Detachment above boottop and along horizontal weld on PS forward area.

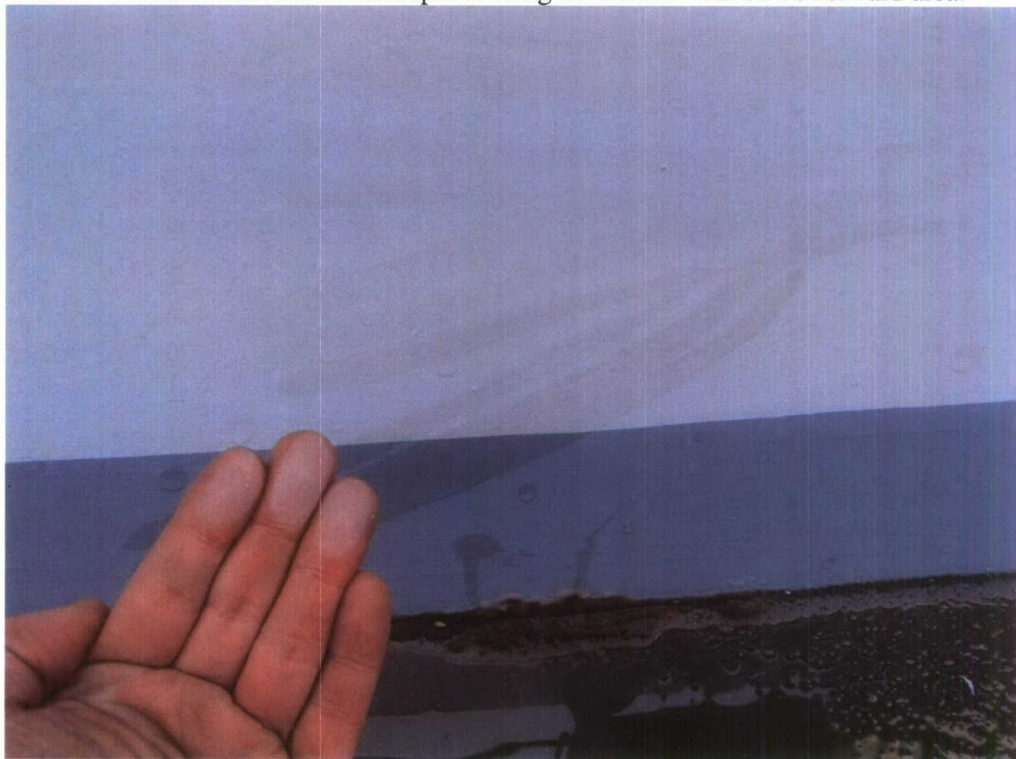
Photo 24: Hr.Ms. "De Ruyter" (LCF 3). Superstructure (08.12.2006).  
C deck. Powdery coating surface. Corrosion along welding corner.

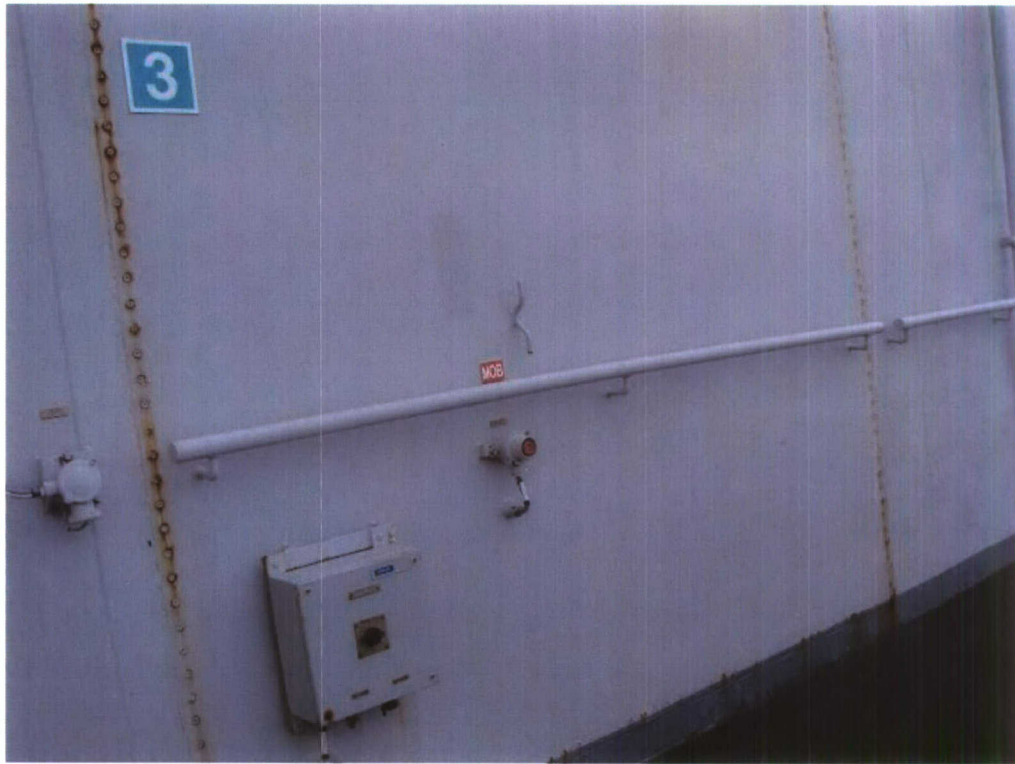
Photo 25: Hr.Ms. "De Ruyter" (LCF 3). Superstructure (08.12.2006).  
D deck. SB forward. Corrosion around stainless steel head screws.

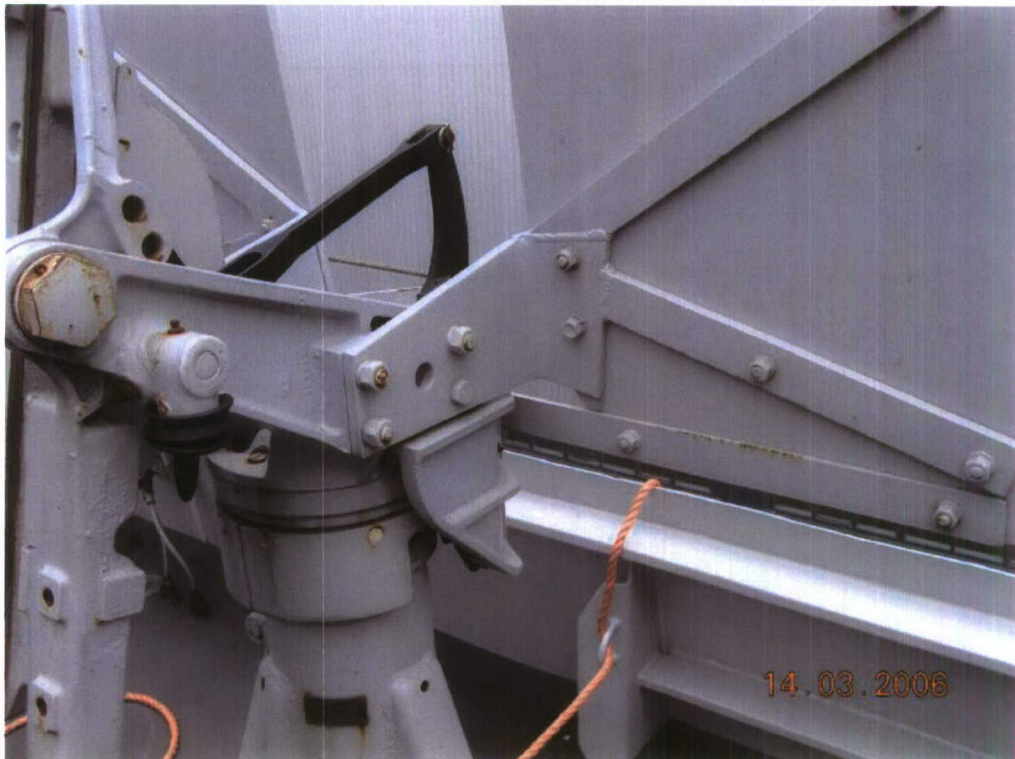
Photo 26: Hr.Ms. "Evertsen" (LCF4). Superstructure (14.03.2006).  
D deck. PS forward. Corrosion on various details.
